# Coalhouse Fort, East Tilbury, Essex

## Feasibility and Options Study

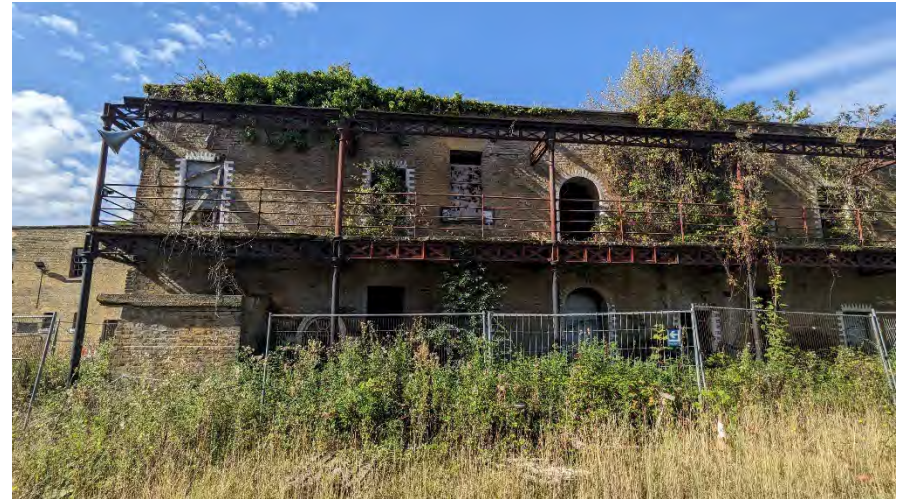
*Figure 26 The Barracks are an example of part of the Site which is currently unusable, due to its current condition*

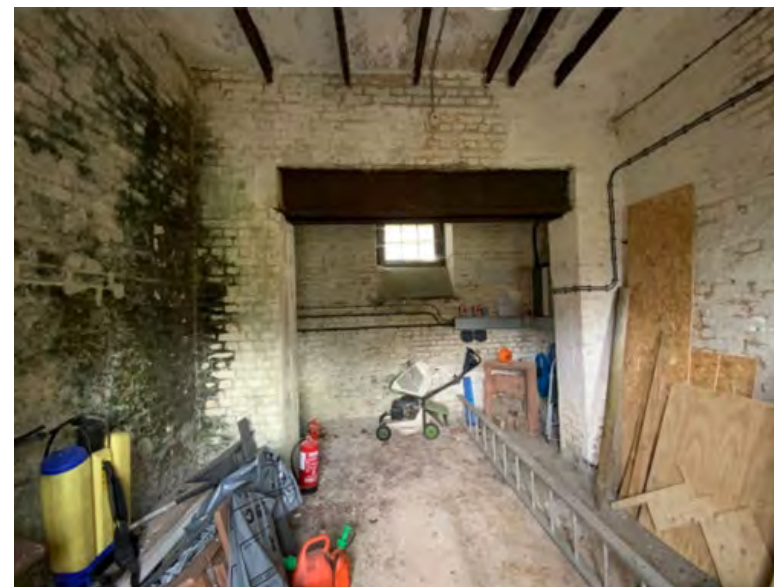
Figure 37 Room Number G/01

| <b>CONDITION / COMMENTS:</b> | Fair; evidence of damp ingress generally – algae growth to south wall (adjacent to earth bank – acts as a retaining wall); deteriorating finishes generally; rust to 1 <sup>st</sup> floor beams |

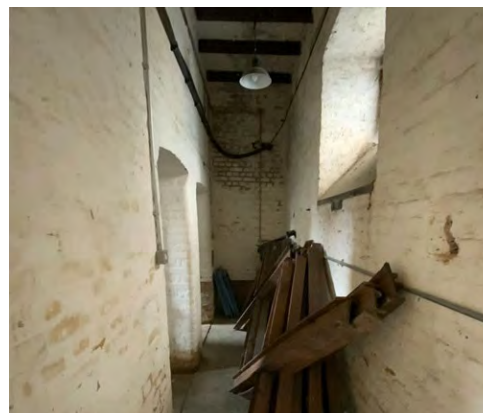
Figure 38 Room Number G/02

| <b>CONDITION / COMMENTS:</b> | <p>Fair; evidence of damp ingress generally esp, walls at low level &amp; some algae growth; deteriorating finishes generally; rust to 1<sup>st</sup> floor beams</p> <p>Some potential for interpretation – law &amp; order within the Fort when operational</p> |

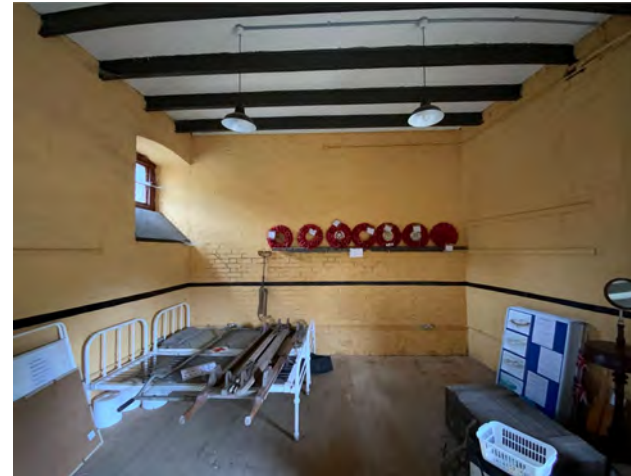
Figure 41 View north into room Number G/05

| <b>CONDITION / COMMENTS:</b> | Good; minor evidence of damp ingress generally esp, walls at low level; finishes generally good condition |

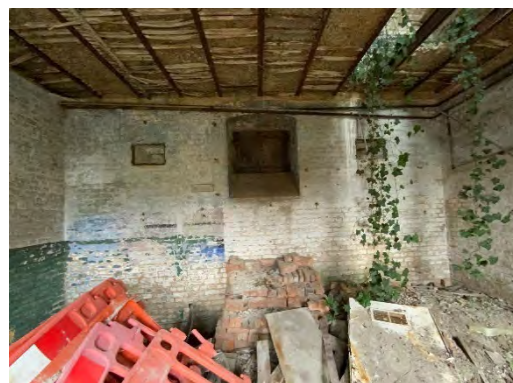
Figure 43 View into room G/06 (1)

| <b>CONDITION / COMMENTS:</b> | Very poor; space is derelict with loss of floor / ceiling / elements of 1 <sup>st</sup> floor over; finishes very poor good condition |

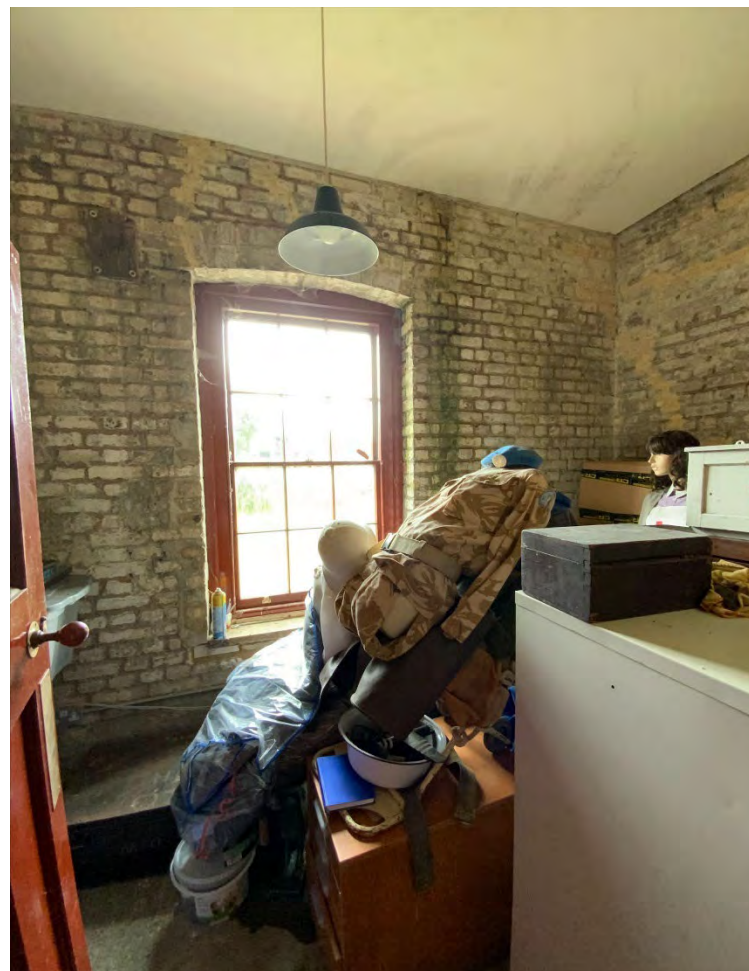
Figure 47 Room Number 1/01

| <b>CONDITION / COMMENTS:</b> | Fair; evidence of damp ingress generally at ceiling level to perimeter (roof leaks) ; finishes generally poor condition<br><br>Condition of finishes could be left as part of interpretation (strategy adopted at previous refurbishment c 2010) |

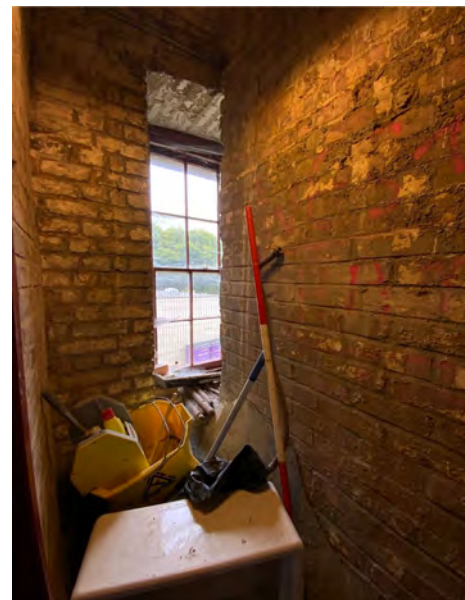
Figure 48 Room Number 1/03

| <b>CONDITION / COMMENTS:</b> | Fair; evidence of damp ingress generally at ceiling level to perimeter (roof leaks); finishes generally poor condition<br><br>Condition of finishes could be left as part of interpretation (strategy adopted at previous refurbishment c 2010) |

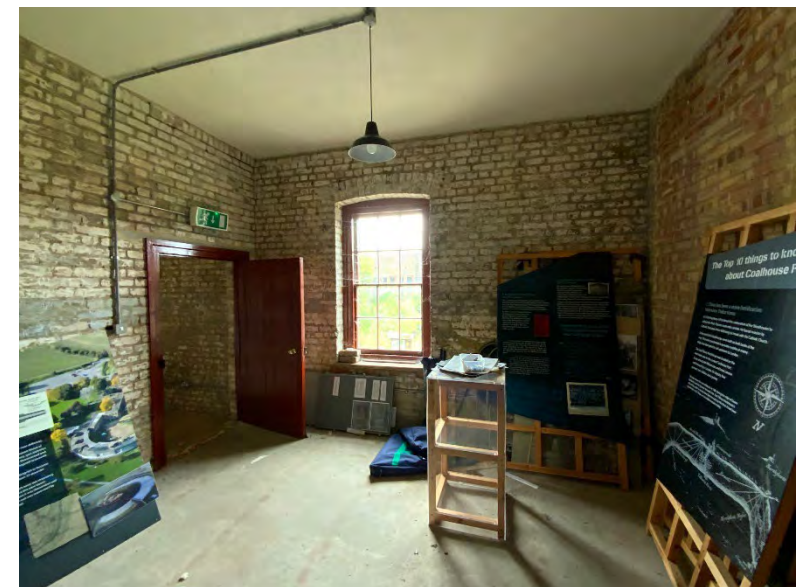
Figure 50 Room Number 1/04

| <b>CONDITION / COMMENTS:</b> | Fair; evidence of damp ingress generally at ceiling level to perimeter (roof leaks) ; finishes generally poor condition<br><br>Condition of finishes could be left as part of interpretation (strategy adopted at previous refurbishment c 2010) |

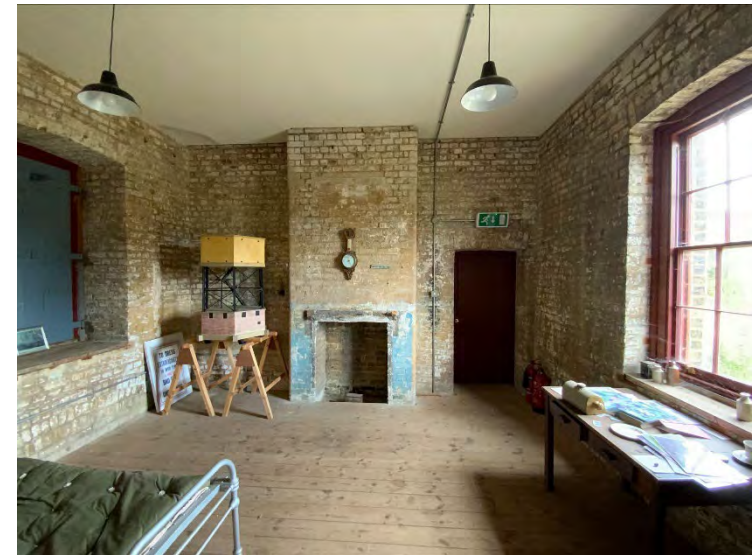
Figure 51 Room Number 1/05

| <b>CONDITION / COMMENTS:</b> | <p>Fair; evidence of damp ingress generally at ceiling level to perimeter (roof leaks) ; finishes generally poor condition</p> <p>Condition of finishes could be left as part of interpretation (strategy adopted at previous refurbishment c 2010)</p> |

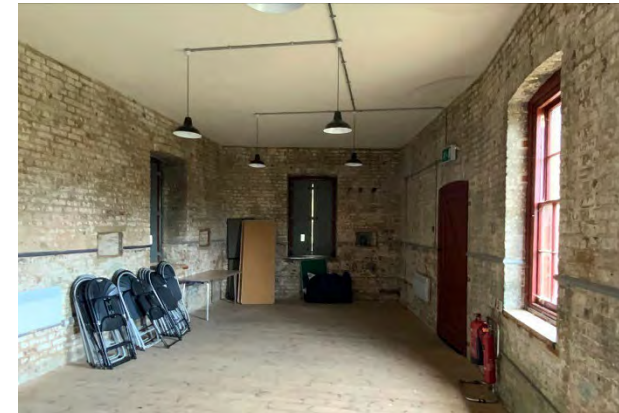
Figure 52 View south into room number 1/06

| <b>CONDITION / COMMENTS:</b> | Fair; evidence of damp ingress generally at ceiling level to perimeter (roof leaks); finishes generally poor condition<br><br>Condition of finishes could be left as part of interpretation (strategy adopted at previous refurbishment c 2010) |

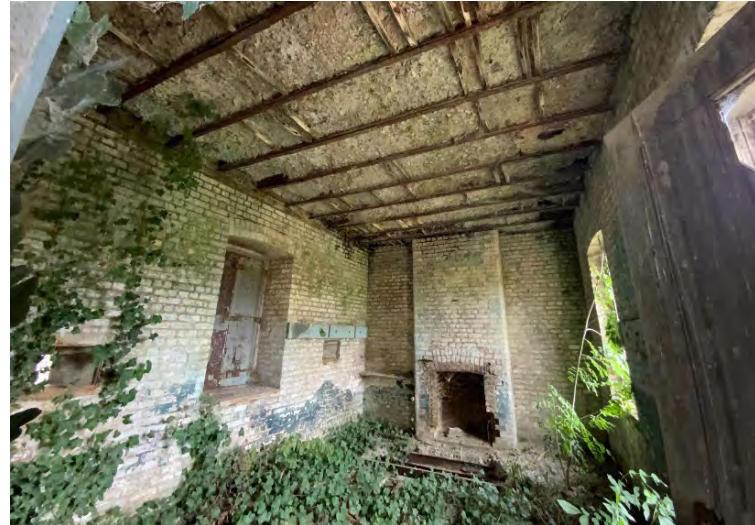
Figure 54 Room Number 1/07

| <b>CONDITION / COMMENTS:</b> | Very poor; space is derelict with loss of floor / ceiling / elements of roof over; finishes very poor good condition |

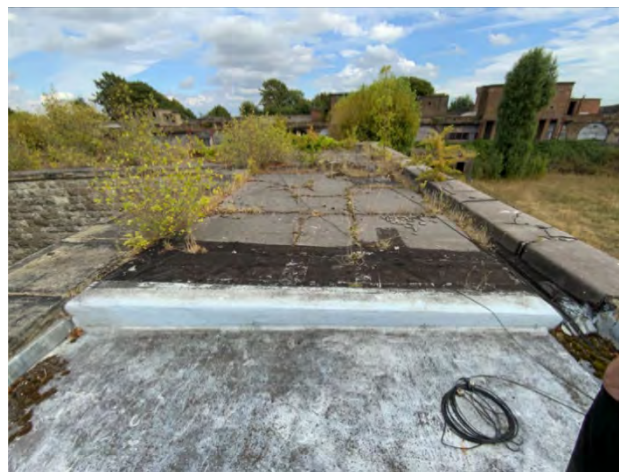
Figure 57 Roof – North Range

| <b>CONDITION / COMMENTS:</b> | <p>Fair; evidence of damp ingress internally at ceiling level to perimeter indicating roof leaks at junction with upstands</p> <p>North range roof = very poor condition with considerable cracking &amp; vegetation growth</p> |

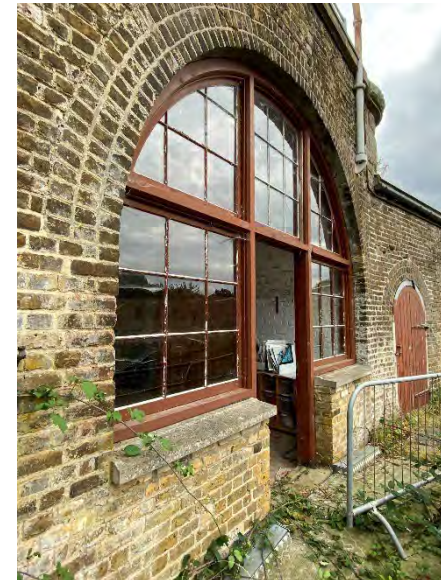
Figure 99 Exterior of Unit Number 1

| <b>CONDITION / COMMENTS:</b> | Fair; evidence of damp ingress generally; deteriorating finishes throughout |

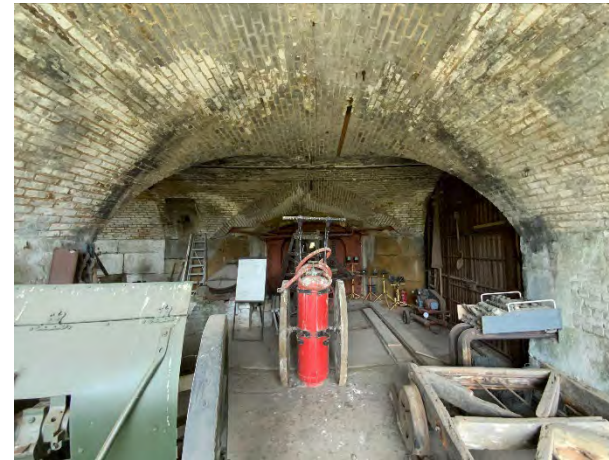
Figure 101 Interior of Room Number 2

| <b>CONDITION / COMMENTS:</b> | Poor; evidence of damp ingress generally; washing out of mortar joints and deteriorating finishes and staining to brickwork throughout |

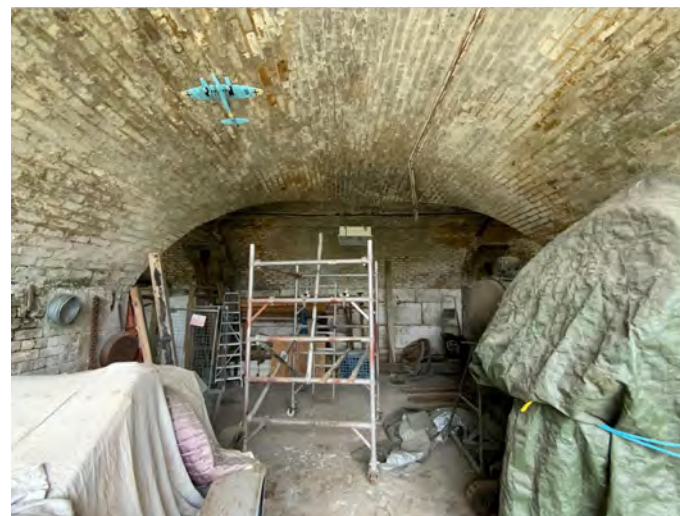
*Figure 103 Interior of Room Number 3*

| <b>CONDITION / COMMENTS:</b> | Poor; evidence of damp ingress generally; washing out of mortar joints and deteriorating finishes and staining to brickwork throughout |

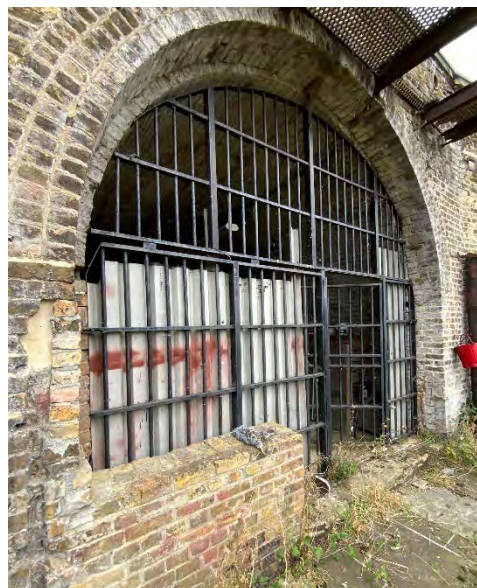
*Figure 105 Exterior of Room Number 4*

| <b>CONDITION / COMMENTS:</b> | Poor; evidence of damp ingress generally; washing out of mortar joints and deteriorating finishes and staining to brickwork throughout; cracking to apex of brick vaulting and algae growth around gun port and centre of plan; rust / corrosion to gun port |

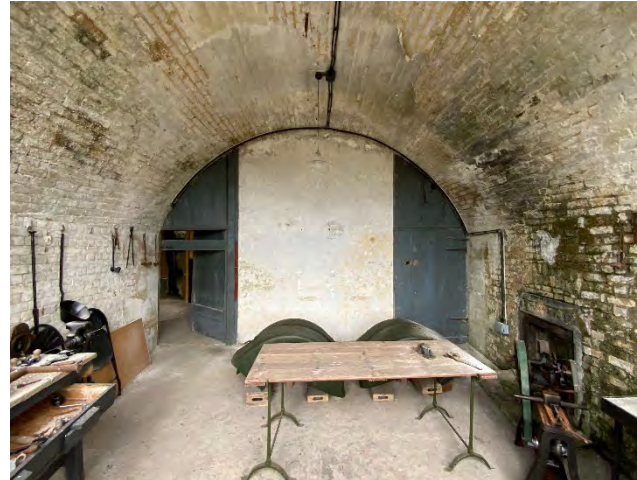
*Figure 107 Interior of Room Number 5*

| <b>CONDITION / COMMENTS:</b> | Poor; evidence of damp ingress generally; washing out of mortar joints and deteriorating finishes and staining and algae growth to brickwork throughout |

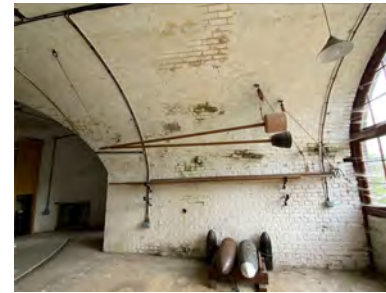
*Figure 109 Interior of Room 6 (looking west)*

**CONDITION / COMMENTS:** Poor; evidence of damp ingress generally; washing out of mortar joints and deteriorating finishes and staining to brickwork throughout; cracking to apex of brick vaulting and extreme algae growth around gun port and centre of plan; rust / corrosion to gun port

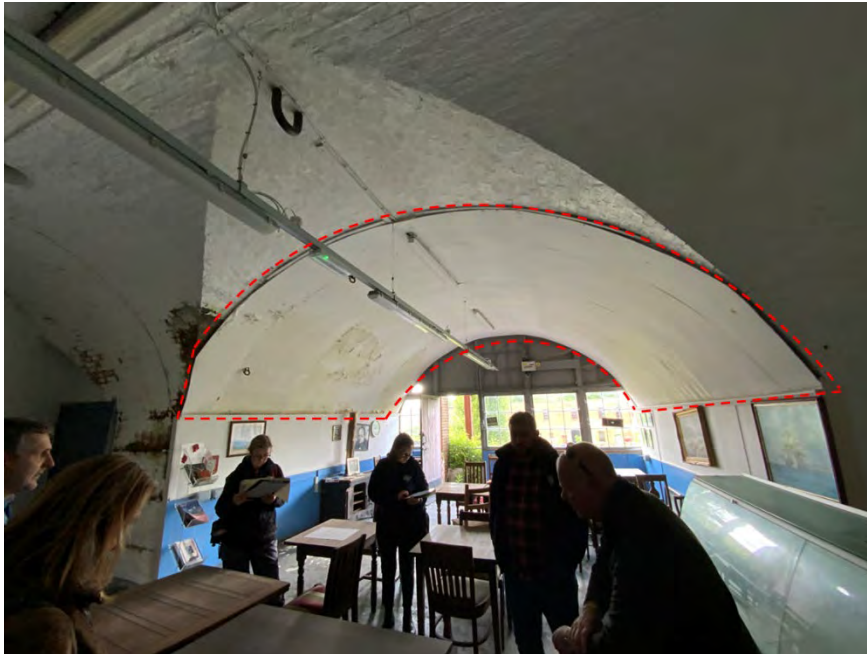
*Figure 137 Example of existing lining to vaults; the peeling finishes, staining and 'rippled' surface are as a result of the use of incorrect non-waterproof materials.*
