# Coalhouse Fort, East Tilbury, Essex

## Feasibility and Options Study

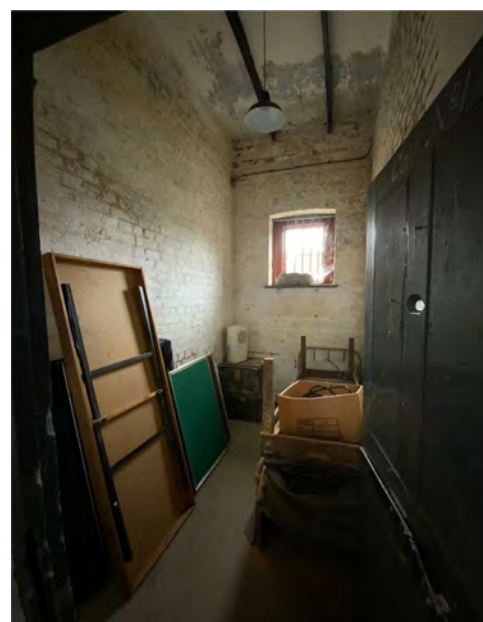
Figure 39 Room Number G/03

| <b>CONDITION / COMMENTS:</b> | <p>Fair; evidence of damp ingress generally esp, walls at low level &amp; some algae growth; deteriorating finishes generally; rust to 1<sup>st</sup> floor beams</p> <p>Some potential for interpretation – law &amp; order within the Fort when operational</p> |

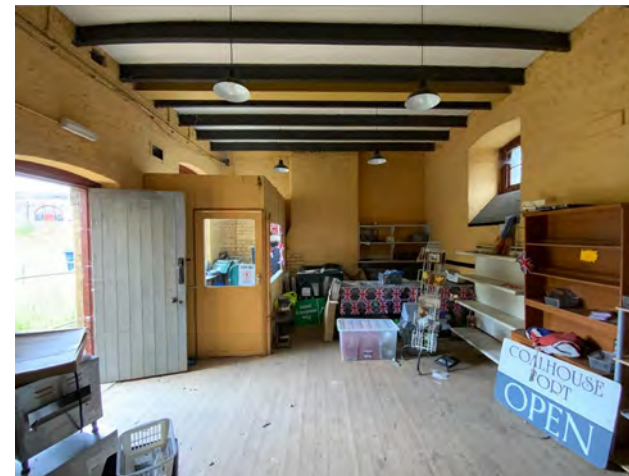
Figure 42 View south into room Number G/05

| <b>CONDITION / COMMENTS:</b> | Good; minor evidence of damp ingress generally esp, walls at low level; finishes generally good condition |

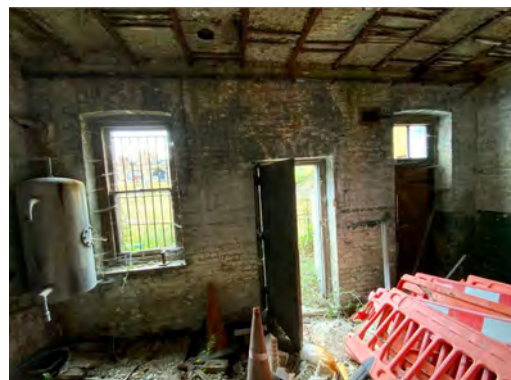
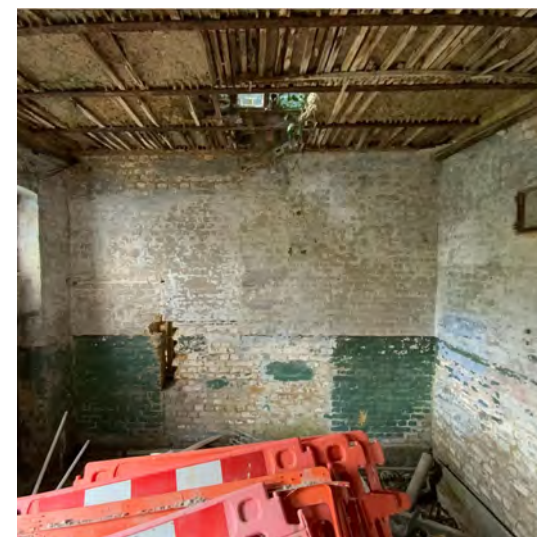
| <b>CONDITION / COMMENTS:</b> | Very poor; space is derelict with loss of floor / ceiling / elements of 1 <sup>st</sup> floor over; finishes very poor good condition |

Figure 44 View into room Number G/06 (2)

Figure 45 View into room G/06 (3)

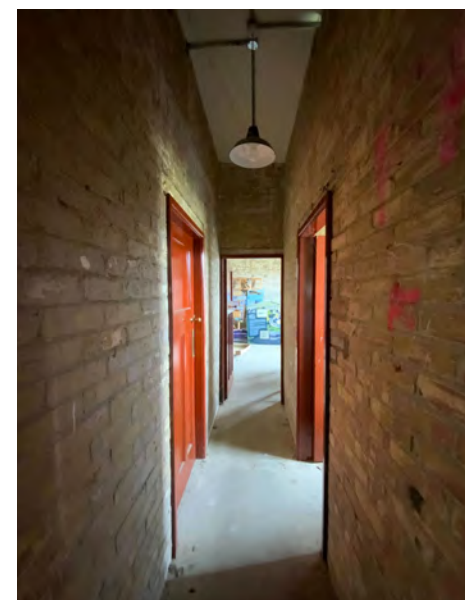
Figure 49 Room Number 1/02

| <b>CONDITION / COMMENTS:</b> | Fair; evidence of damp ingress generally at ceiling level to perimeter (roof leaks); finishes generally poor condition<br><br>Condition of finishes could be left as part of interpretation (strategy adopted at previous refurbishment c 2010) |

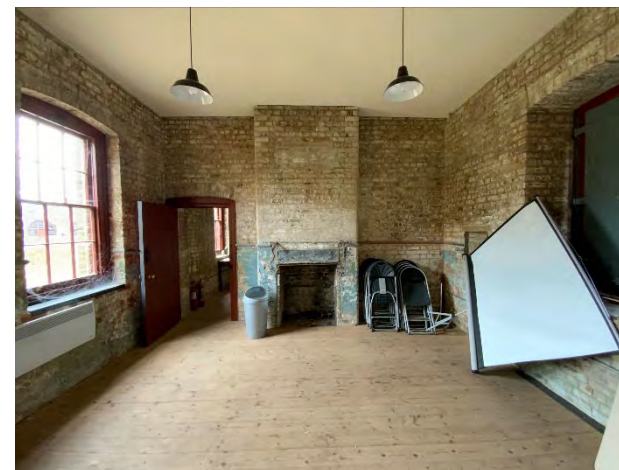
Figure 53 View north into room number 1/06

| <b>CONDITION / COMMENTS:</b> | Fair; evidence of damp ingress generally at ceiling level to perimeter (roof leaks); finishes generally poor condition<br><br>Condition of finishes could be left as part of interpretation (strategy adopted at previous refurbishment c 2010) |

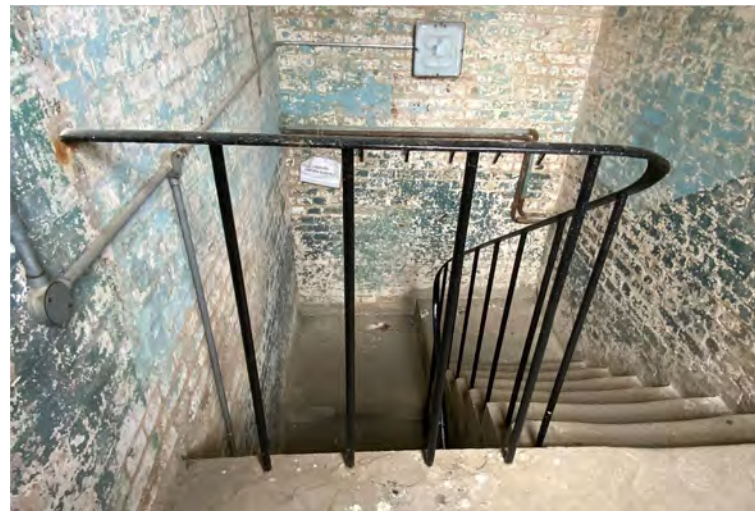
Figure 55 Stairs Number ST/02

| <b>CONDITION / COMMENTS:</b> | <p>Fair; minor evidence of damp ingress generally esp, walls at low level; finishes generally poor condition</p> <p>Condition of finishes could be left as part of interpretation (strategy adopted at previous refurbishment c 2010)</p> <p>Stair handrail height &amp; gaps between balusters do not conform to building regulations</p> |

This is an original stair with York Stone treads and wrought iron balustrading and handrail. The stair is not ideal from a Building Regulations perspective, with winders to the foot of the stair and relatively high risers, however it is of high heritage significance so opportunities for alterations are limited. It is considered that the stair will be acceptable given the proposed lift provision.

The balustrading at the top landing is 930 mm high, below the regulation 1100 mm, and the gaps between the balusters are c 210 mm, in excess of the required 100 mm. This presents a risk from falling. Consequently, it is proposed to raise the height and provide infill panels to the balustrade. These are to be achieved using bespoke clamps that will bolt-on to the existing and fix into the adjacent wall, making them entirely reversible.

*Figure 74 ST/02 The existing balustrading will be raised in height at the top landing level with infill panels to conform to regulations, these will be bespoke made & clamp on to the existing, enabling full reversibility.*

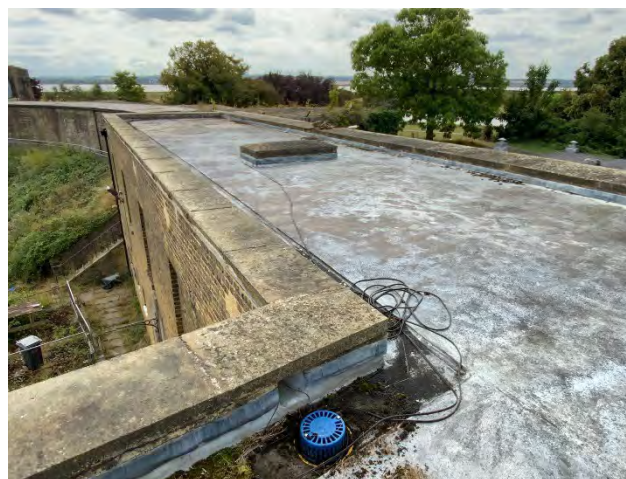
Figure 58 Roof – West Range

| <b>CONDITION / COMMENTS:</b> | <p>Fair; evidence of damp ingress internally at ceiling level to perimeter indicating roof leaks at junction with upstands</p> <p>North range roof = very poor condition with considerable cracking &amp; vegetation growth</p> |

- Refurbish / repair / rebuild north range.
- Repairs to west range as required.

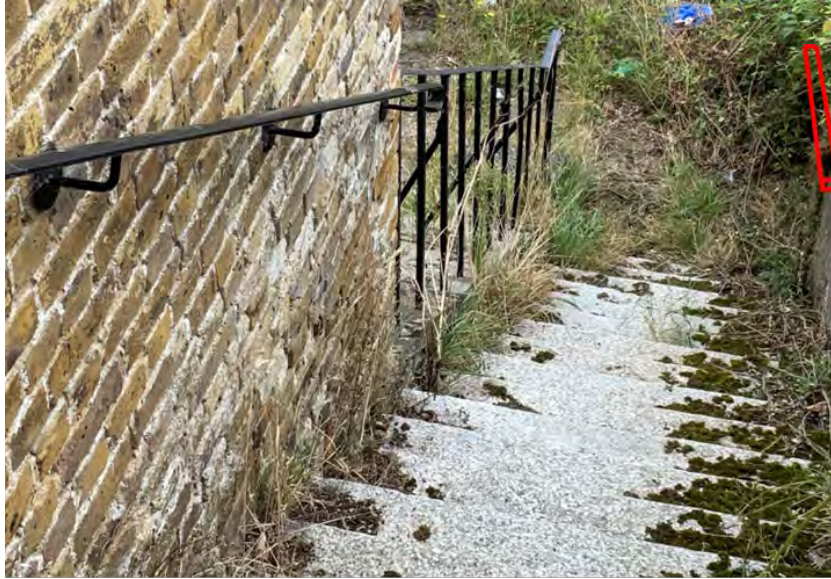
This is an original stair with granite treads. The stair is in reasonable condition, of an acceptable width and pitch. It is of high significance; therefore interventions are proposed to be minimal, relating to clearing of vegetation and repointing of joints between treads and junctions with the adjacent brick walls in lime mortar. To improve access, it is proposed to fit a new continuous handrail to the south wall so that there is a handrail to both sides. The handrail will be in painted steel to match the original section of balustrading to the foot of the stair.

*Figure 72 Vegetation on ST/01 will be cleared*

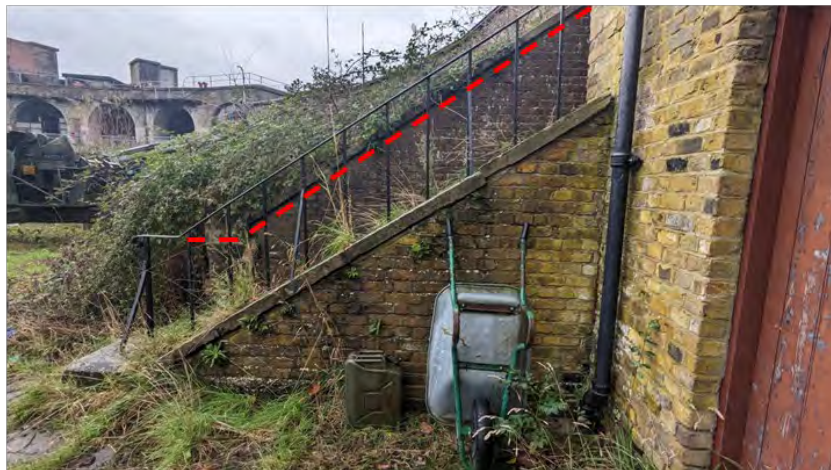
*Figure 73 ST/01 a continuous handrail provided to the south side of the stair in addition to the existing, improving accessibility*

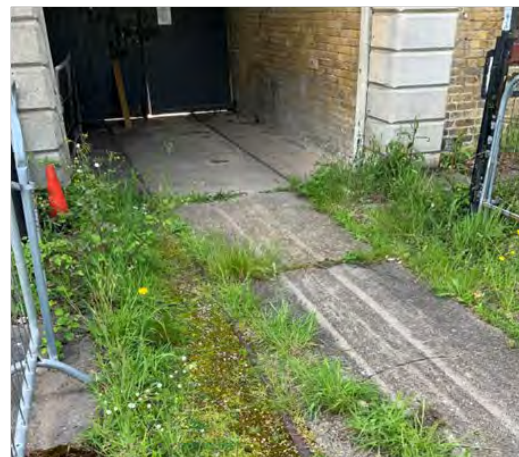
Figure 78 view west of entrance archway

Horizontal access begins at the entrance archway to the Site. The area through the archway and immediately inside the Site presents a number of impediments to free movement, with uneven surfacing, old footings and vegetation presenting trip hazards and restricting the area generally.

It is proposed to provide an enlarged open area immediately adjacent to the Guardhouse. This will provide easy and safe access into the Site for all visitors, an orientation space on entry, a space for equipment to be unloaded for events. Initial proposals are for this area to be surfaced with resin-bonded gravel, providing a visually comparable but more user-friendly version of the loose gravel to the adjacent Parade Ground.

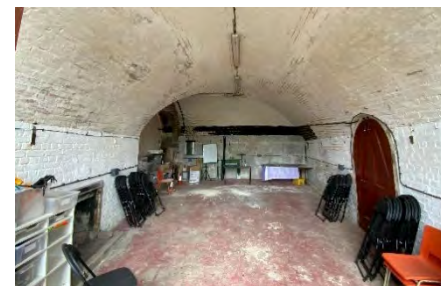
Figure 100 Interior Unit Number 1

| <b>CONDITION / COMMENTS:</b> | Fair; evidence of damp ingress generally; deteriorating finishes throughout |

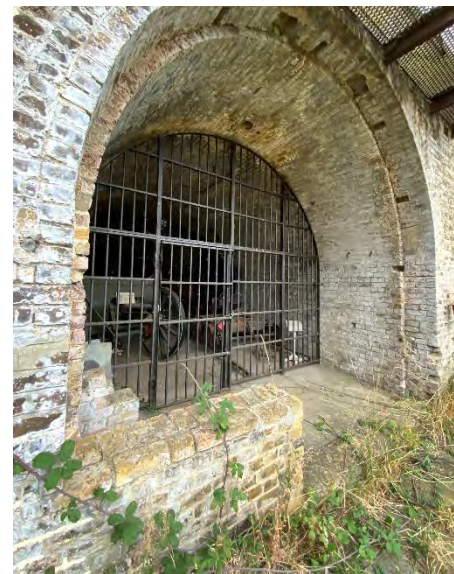
Figure 102 Exterior of Room Number 2

| <b>CONDITION / COMMENTS:</b> | Poor; evidence of damp ingress generally; washing out of mortar joints and deteriorating finishes and staining to brickwork throughout |

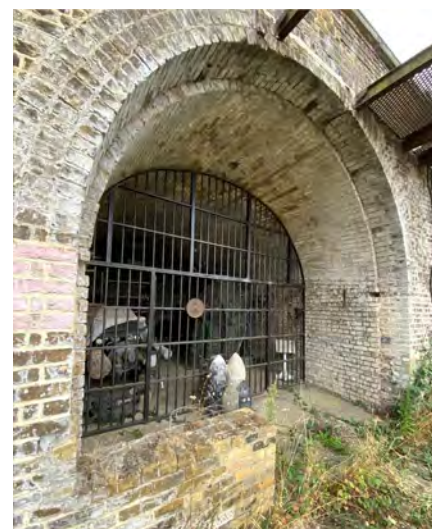
*Figure 104 Exterior of Room Number 3*

| <b>CONDITION / COMMENTS:</b> | Poor; evidence of damp ingress generally; washing out of mortar joints and deteriorating finishes and staining to brickwork throughout |

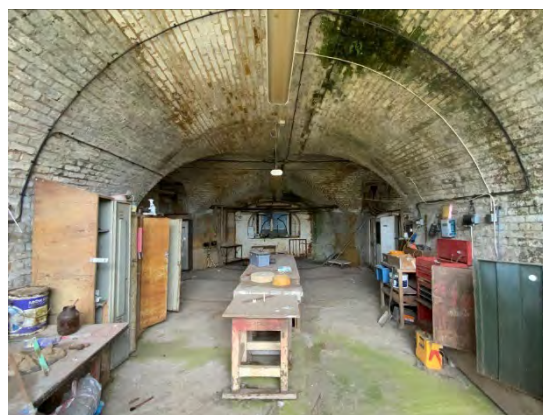
*Figure 106 Interior of Room Number 4*

| <b>CONDITION / COMMENTS:</b> | Poor; evidence of damp ingress generally; washing out of mortar joints and deteriorating finishes and staining to brickwork throughout; cracking to apex of brick vaulting and algae growth around gun port and centre of plan; rust / corrosion to gun port |

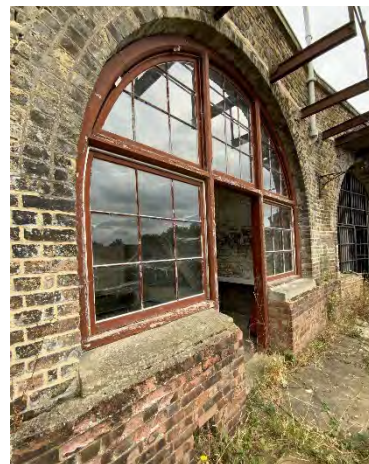
*Figure 108 Exterior of Room Number 5*

| <b>CONDITION / COMMENTS:</b> | Poor; evidence of damp ingress generally; washing out of mortar joints and deteriorating finishes and staining and algae growth to brickwork throughout |

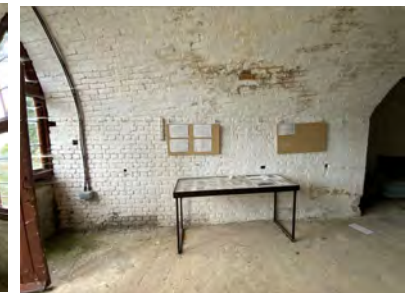
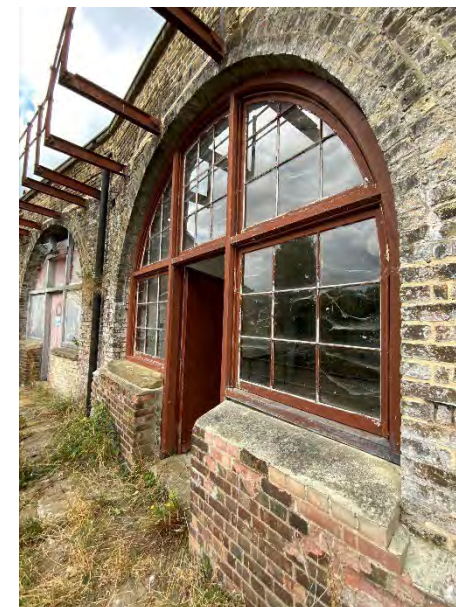
**CONDITION / COMMENTS:** Poor; evidence of damp ingress generally; washing out of mortar joints and deteriorating finishes and staining to brickwork throughout; cracking to apex of brick vaulting and extreme algae growth around gun port and centre of plan; rust / corrosion to gun port

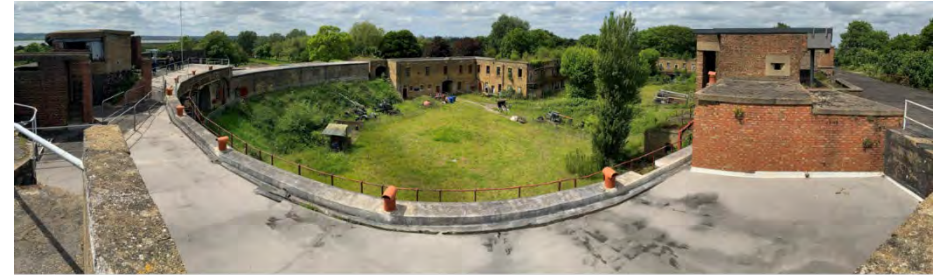
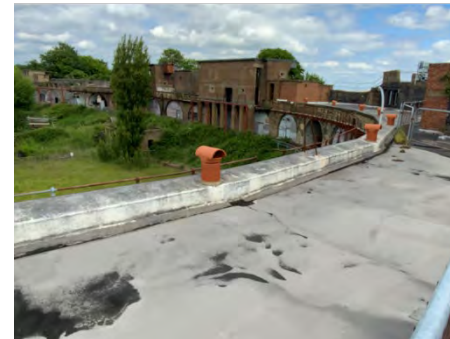
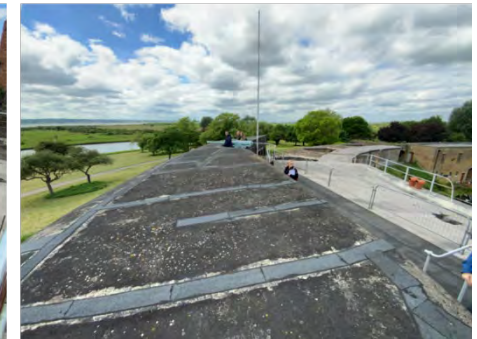
Figure 117 Roof units 1 - 6

| <b>DECK:</b> | Brick vault with rendered surface (appears cementitious) overlaid with asphalt; bituminous felt repairs over cracking |
| <b>CONDITION / COMMENTS:</b> | <p>Fair / poor; evidence of cracking to asphalt causing damp ingress internally; repairs to cracks with bituminous felt</p> <p>Form of roof with various structures projecting above surface makes waterproofing difficult; curved profile of south edge with no drip results in water running over the wall surface below causing water ingress particularly around gun ports.</p> <p>Previous attempts to waterproof the structures have largely failed.</p> |
